cleanfix[®]

Ready for the Champions League!

Get a playmaker for your sports hall.

The robot RA660 Navi cleans your sports hall twice a day:
hygienically clean - extremely reliable - inexpensive
Everything about the new team player at www.ra660navi.com

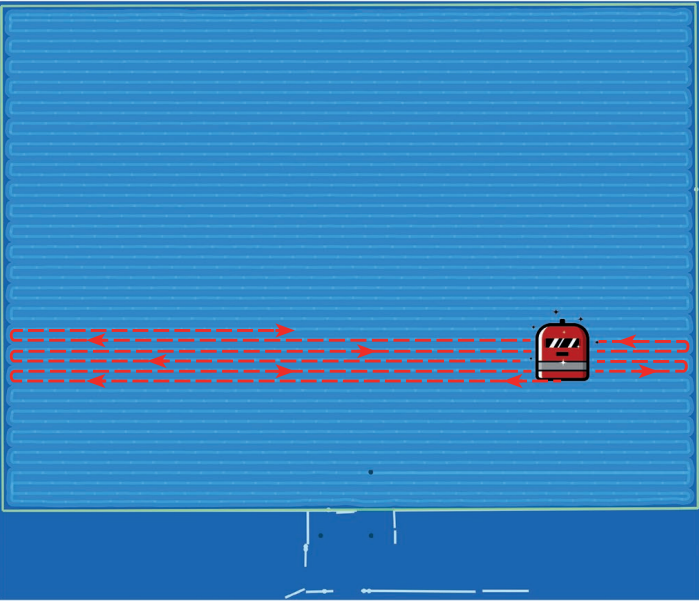
Cleaning Report

Cleaned area Cleaned surface: 1481.99 m² Zone 10

This cleaning report shows a sports hall with 1481.99 m² cleaned in one hour and ten minutes (1:10:21).

The cleaning paths (marked red) of the robot are clearly visible. You have full control that the entire hall is cleaned. No source of error from unnecessarily double cleaned areas or from forgotten areas.
